Beales Corner Temporary Barrier System Post Incident Review

Date: July 2021

Version: Final v1

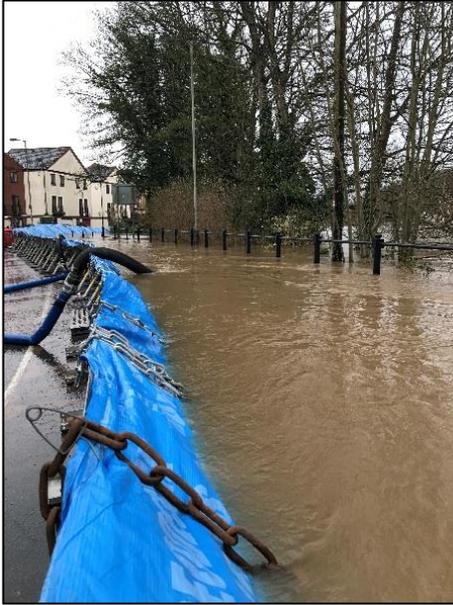
Leakage often occurs at low water levels and combines with surface water. To minimise this the membrane is weighted with chains and 2 x 6” Pioneer Pumps can be deployed behind the barrier connected to the road drain opposite Rickett’s Place (Figure 4).

Figure 4: Pump discharge hoses can be observed crossing the barrier.

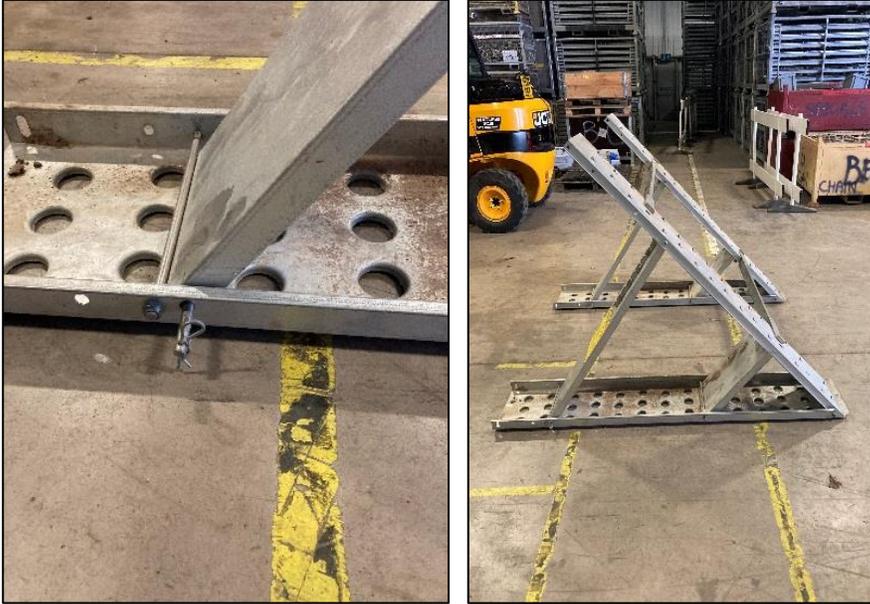
The barrier frames have a tendency to exert high bearing pressures on the bedding surface (in this case the road) (Figures 7 and 8), therefore ground conditions are important when considering deployment.

Figures 7 and 8: Barrier feet with protruding 'collars' which make contact with the surface below.

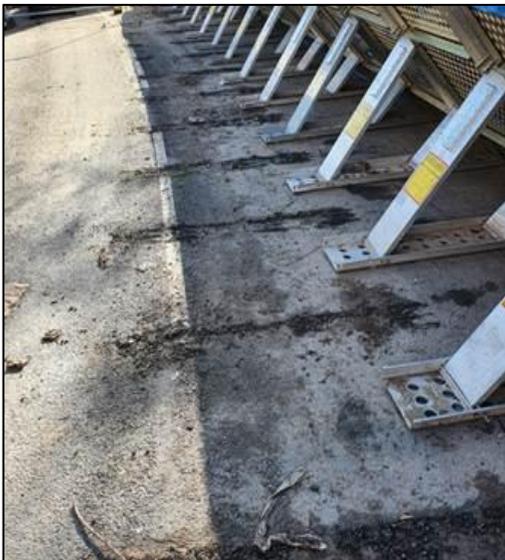
Following the 2019-20 flood event, the surface dressing layer was damaged by the flood barrier to a depth of 10mm (Figure 9). The carriageway remained fit for purpose as a road structure, with damage falling below the requirement for responsive and reactive carriageway maintenance. Care was taken on the subsequent deployment to avoid placing the legs onto the damaged surface.

Figure 9: Damage caused by 2019-20 flood event (Source: Julian Browne, Worcestershire County Council).

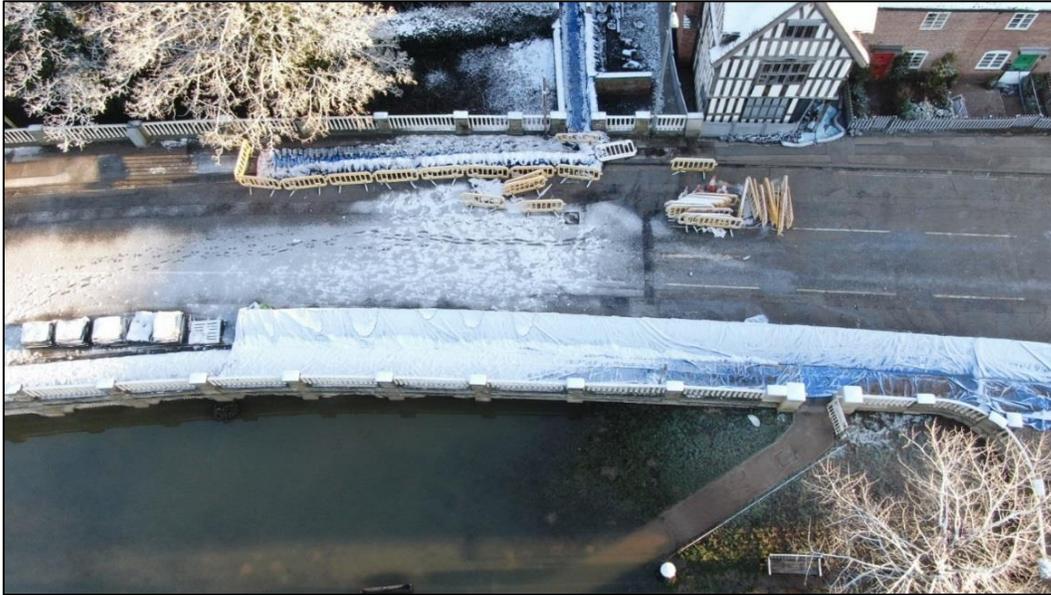
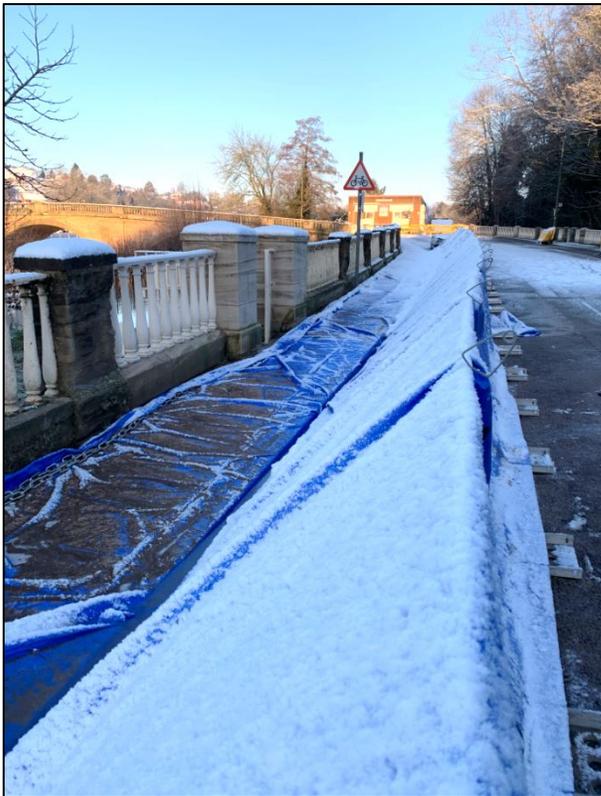
Figure 15: Section1 aerial view.

Section 1 is the northern section of barrier. This was observed to have remained on its original alignment with no visible damage until past the Beales Corner road junction.

The hydrostatic force on this section of the barrier is lowest due to the topography of the road and the membrane apron and chain appeared undisturbed.

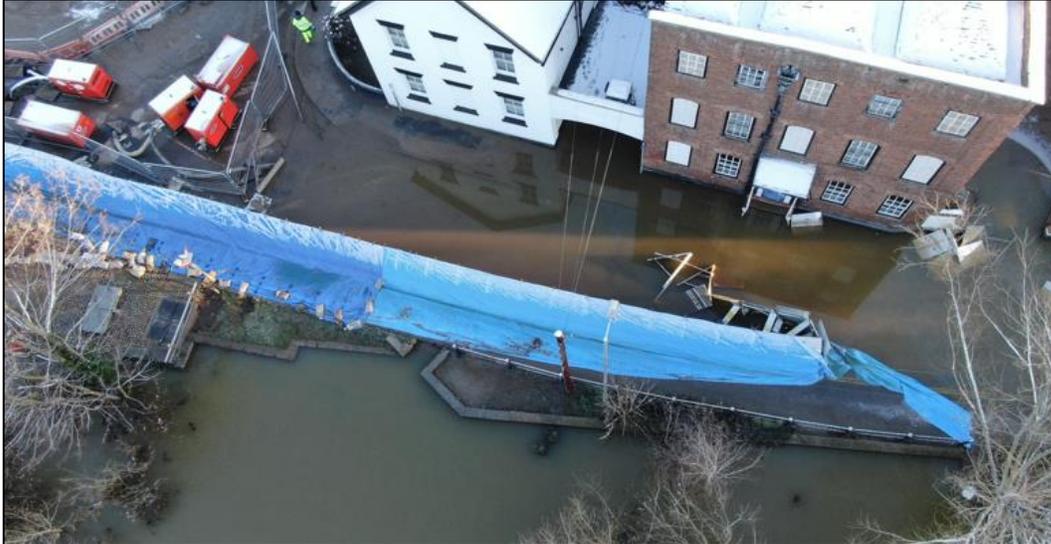
Figure 17: Section 2 aerial view.

Section 2 is the section of temporary barrier which culminates at the breach. At the point of breach the camber was observed to be more significant and the membrane apron had torn. Upstream of the breach, the membrane had displaced toward the toe of the barrier.

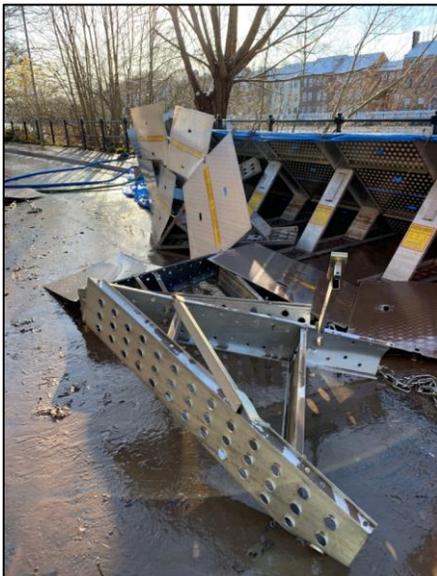
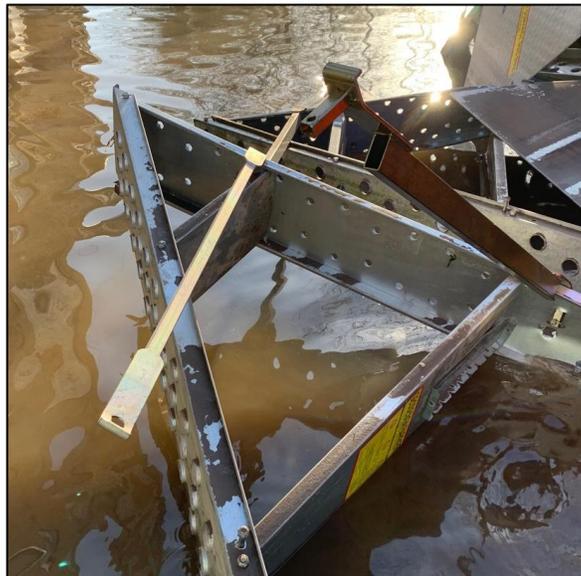
In this location, a spacer bar was observed with its weld broken (in the foreground of Figure 19 compared to the adjacent bar, both twisted) and the barriers were deformed backwards against the back of the adjacent barrier, which was thought to have been caused by the force of the water flowing through the breach point.

Figures 18 and 19: Section of barrier where the breach occurred twisted back, a weld was observed to be broken.

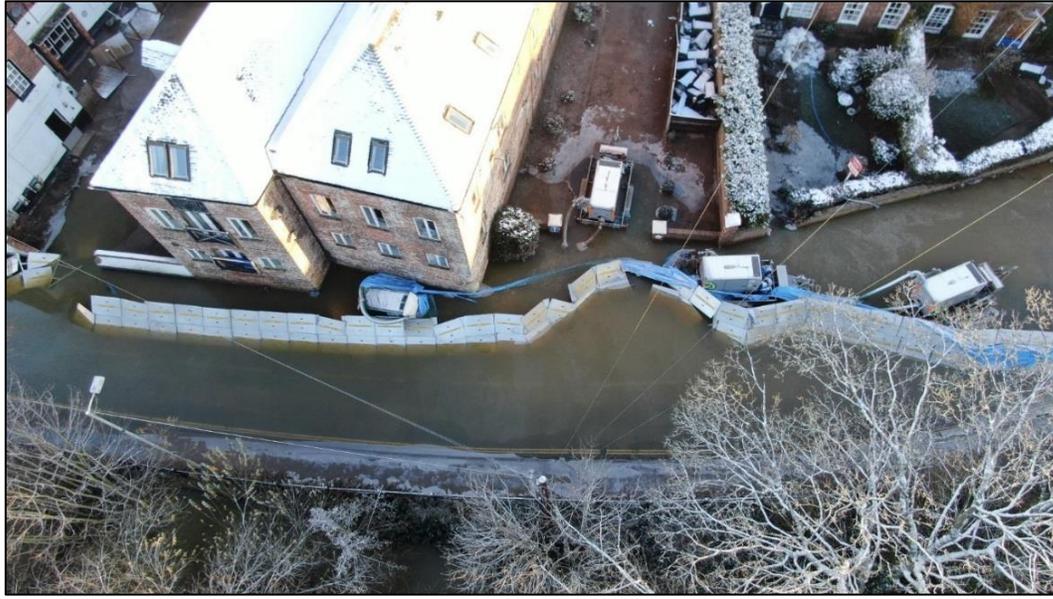
Figure 20: Section 3 aerial view.

Section 3 is comprised of barrier which had moved from its original alignment just behind the toe of the kerb, approximately 4m inland across the road. Damage to the road service in the form of scrape marks was observed as most evident at the entrance to Ricketts Place, which is the low spot in the scheme. This observation ties in with where the initial movement was described by residents and captured by CCTV.

The membrane was damaged and the barrier deformed most at the centre of the slide where there were no kerb or barrier to restrict the lateral movement.

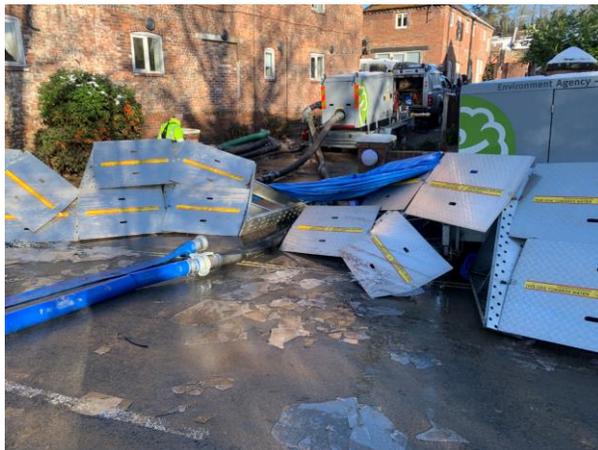
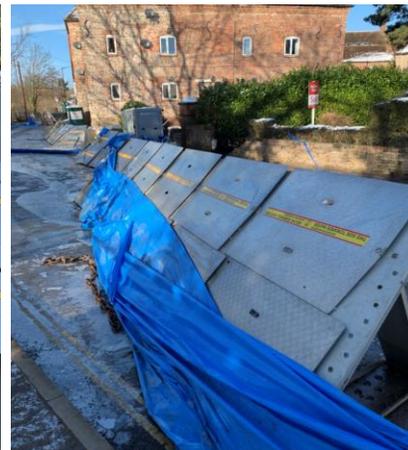
Figures 21 and 22: Section 3.

The assessment considered it likely that as the barrier began to move, and exert force on each adjacent section through the bars and pins, it eventually sheared and breached at the upstream section of Section 3, and was washed backwards against the kerb in this section.

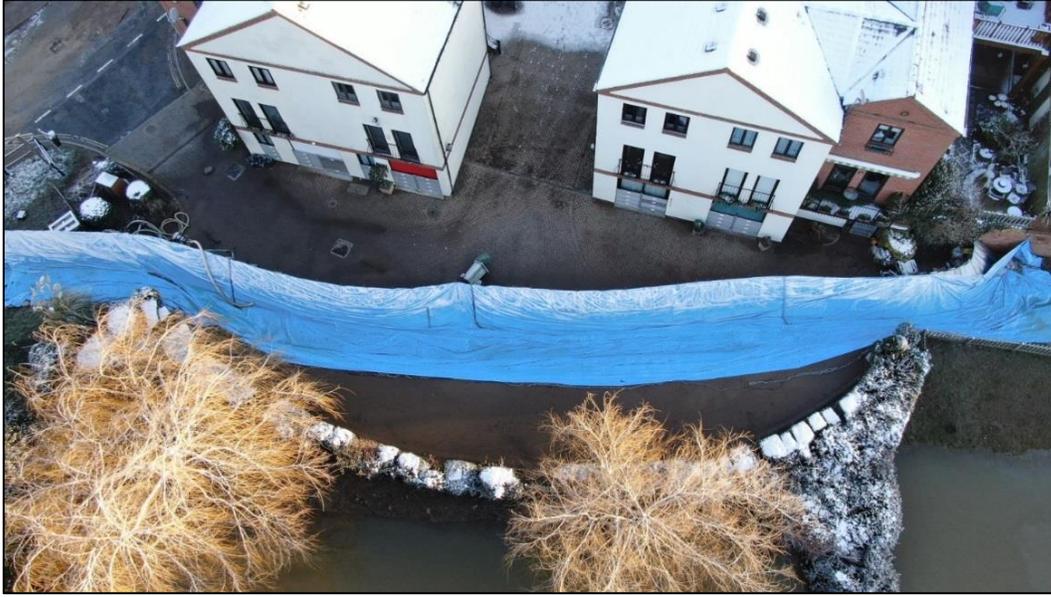
Figure 23: Section 4 aerial view.

Section 4 was recorded as having evidence of compression and displacement at the bottom end, and bins and other debris had struck legs damaging spacer bars and exerting pressure along the line. The alignment remained unchanged, however some material has been washed out and many feet were unevenly seated. At this downstream end of the barrier the camber is minimal and membrane was mostly intact.

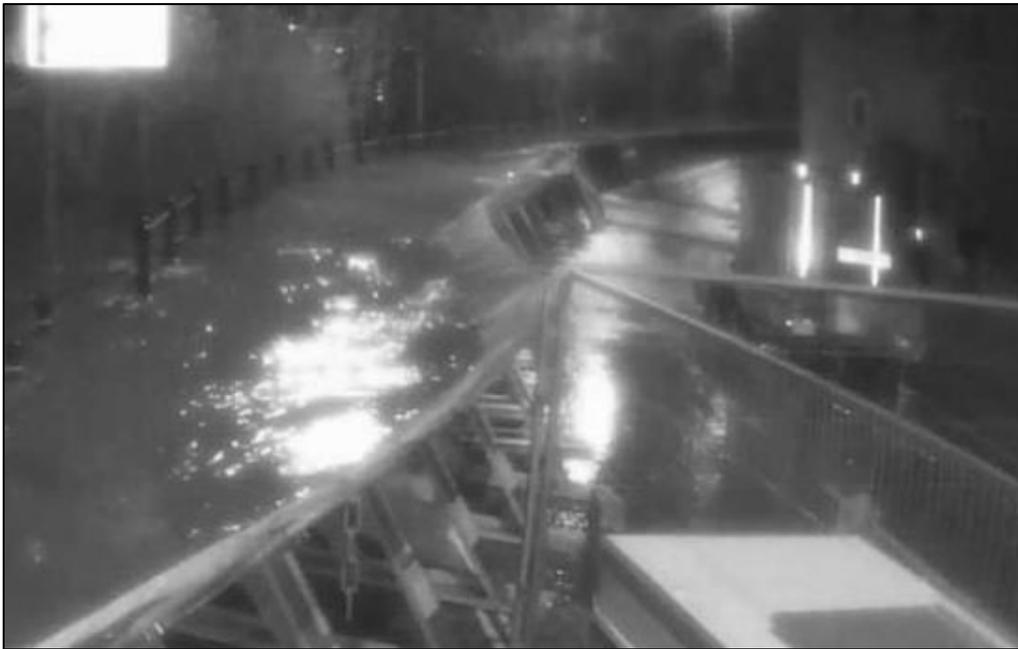
During the incident on 22nd January 2021, the barrier system moved (sliding failure) and sections sheared. Footage captured by remote camera earlier in the day as water loaded the barrier suggested a small initial movement. Just before the breach a more significant inland movement can be observed in the temporary barrier alignment. Eyewitness accounts from residents describe watching the barrier move just before the barrier sheared and the breach occurred.

Figure 25: EA Remote Camera photograph showing inward movement of a section of barrier at the centre of the image at 23:34.

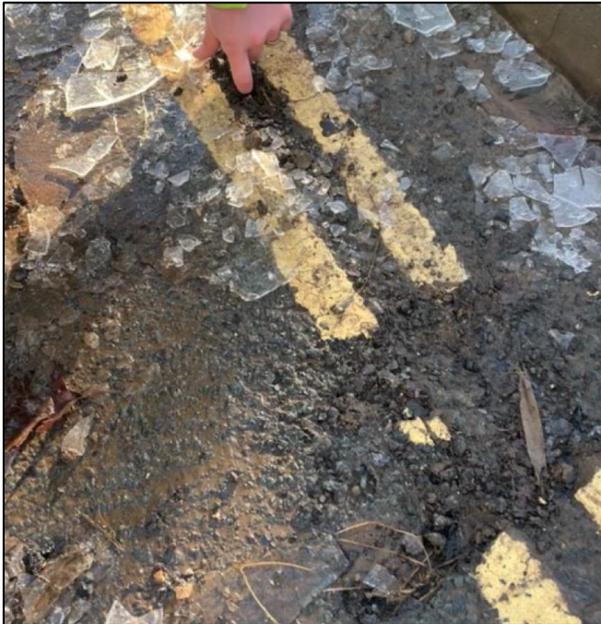
The surface damage to the carriageway caused by the sliding failure suggests that a macro-mechanical failure of the surface has occurred during this event, whereby the metal collars protruding from the base of the barrier have caused damage to the upper surfaces of the pavement. The surface dressing is a spray applied coating of bitumen with chippings which is prone to impact and scraping damage when compared to asphalt, concrete or hot rolled asphalt. Loss of material at the surface is considered to be a result of the 'weaker' surface dressed layer providing a lower level of bonding between dressed layer and pavement structure below (Figure 35).

Figure 35: Loose aggregates in the dressing layer no longer bonded to the pavement structure.

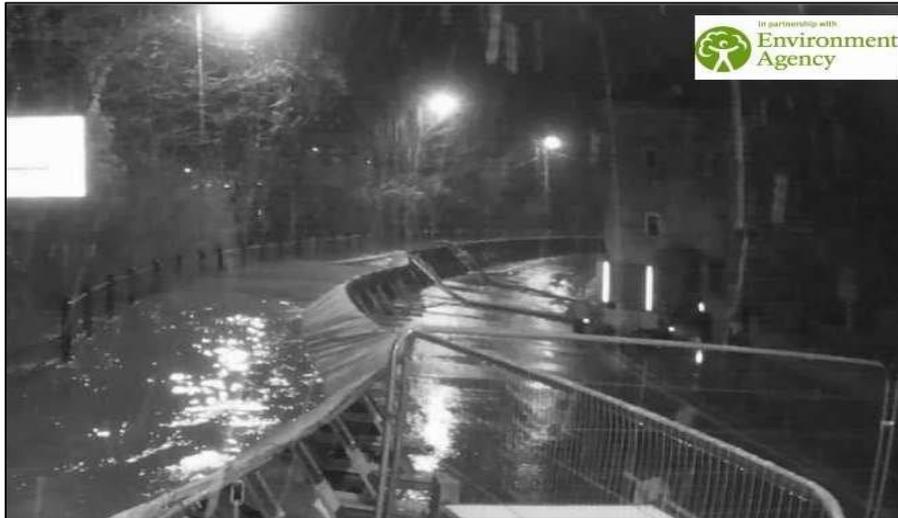
During deployment of the barriers, the barrier manufacturer recommends that pumping capacity be increased to displace any floodwater on the dry side of the barrier caused by permeability of the foundation material or surface water. At Bewdley, the hoses of these pumps are attached to steel A-frames and are positioned over the temporary barrier, as shown in Figure 40.

Figure 40: EA Remote Camera photograph hoses discharging in front of the barrier (taken just prior to figure 25)
