Beales Corner Temporary Barrier System Post Incident Review

Date: July 2021

Version: Final v1

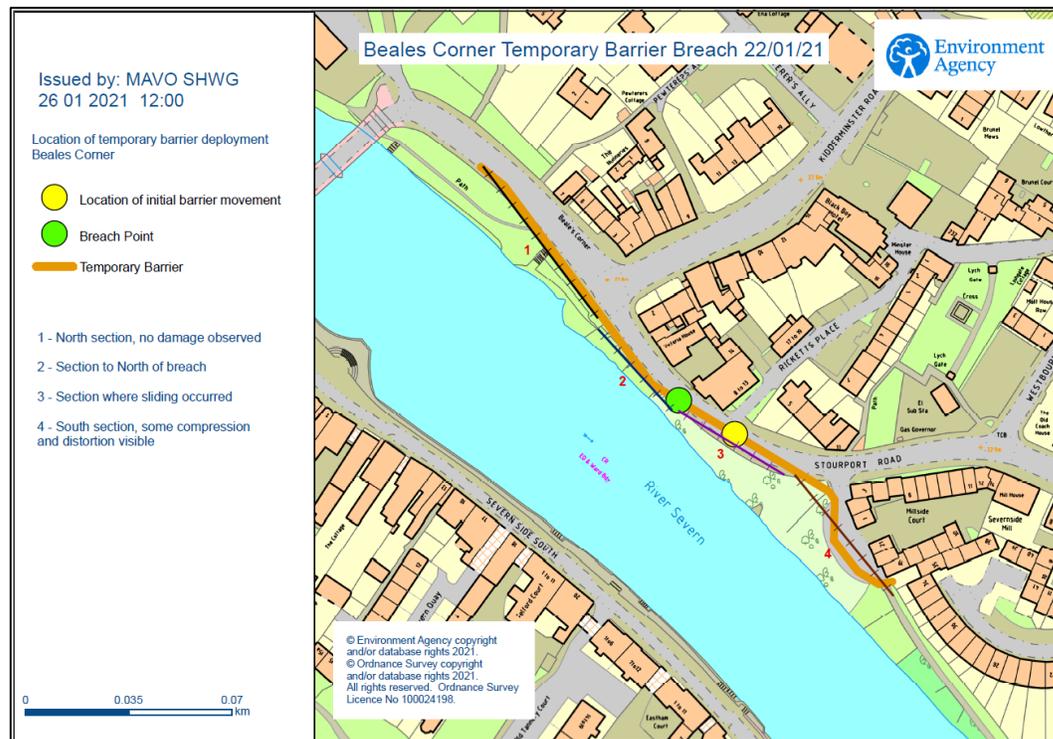
Figure 14: Plan dividing the defence into 4 sections for inspection purposes.

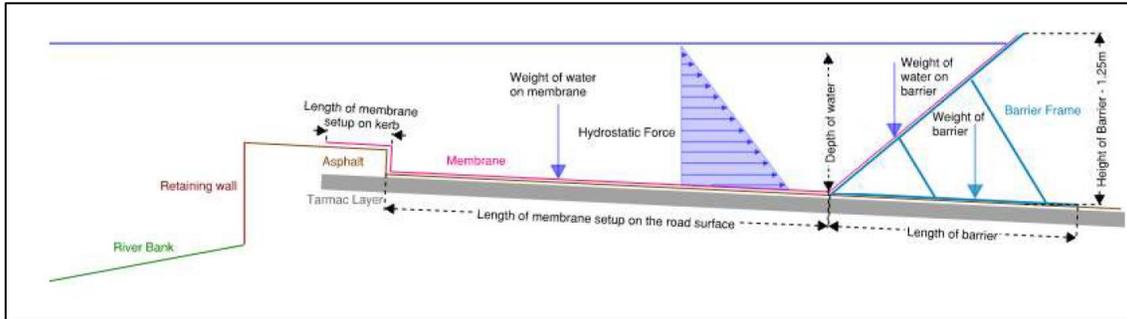
Figure 23 is a representation of the forces acting on the Beales Corner barrier system, including the disturbing force (from the hydrostatic pressure of the water being retained by the defence) and the resisting frictional forces arising from the frame and membrane sliding on the asphalt.

Figure 26: Force Diagram (Source: Arup 2021).

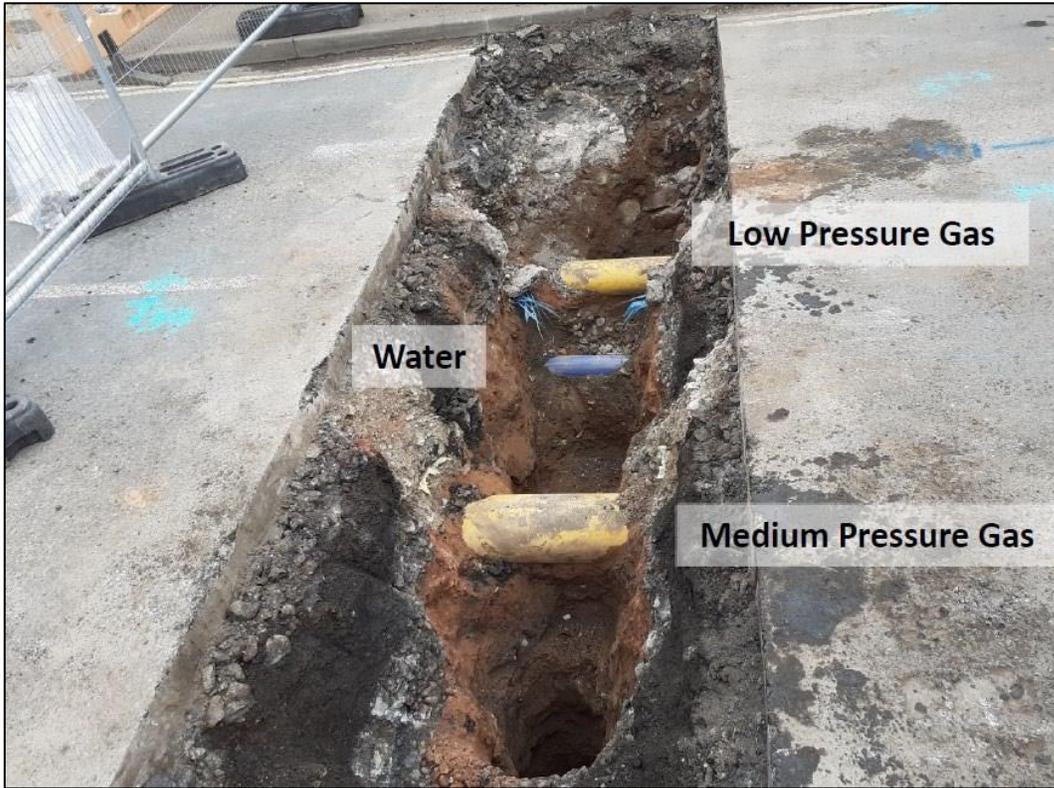
Buried services in the area were very congested which impacted where the investigations could be sighted. This can be observed in Figure 27. The locations of the exploratory holes are shown in Figure 28.

Figure 27: Trial Trench (Source: Arup 2021).

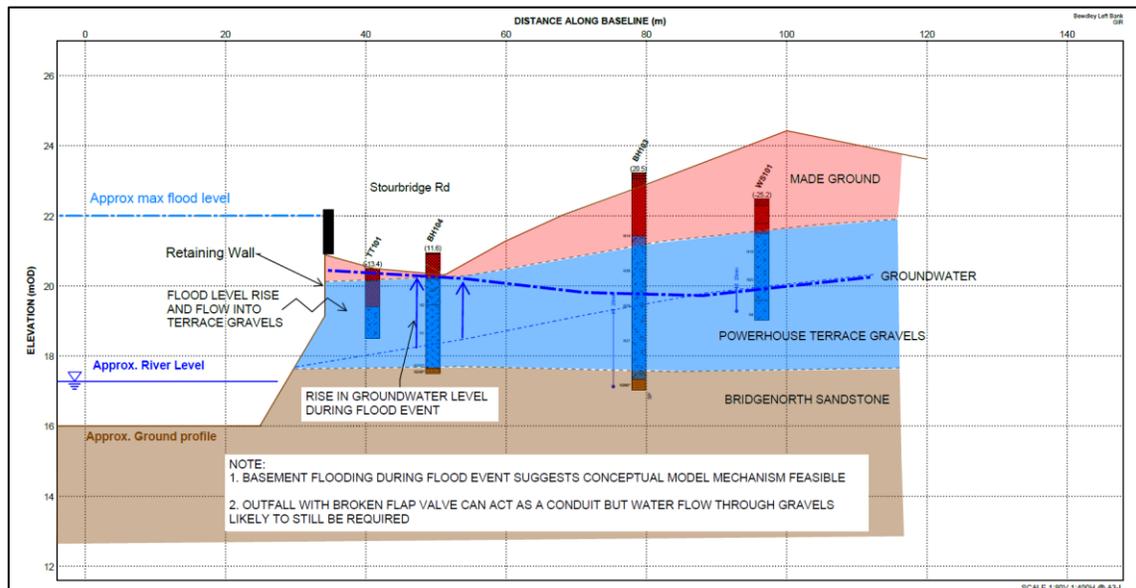
During the ground investigation, groundwater strikes were recorded during the advancement of the majority of the exploratory holes. The typical river level adjacent to the site is approximately 17.5m AOD and the majority of groundwater strikes and subsequent rises were at or up to around 1.5m above the river level. This suggests that there is hydraulic connectivity to the river and forms the basis of the conceptual model for the baseline.

Figure 29: Groundwater Conceptual Model (Source: Arup 2021).

From Figure 29 it can be seen that the granular made ground associated with the road structure is retained by a stone retaining wall around 1m high (along most of Stourport Road). The riverbank is formed within the PHTD and the Bridgnorth Sandstone.

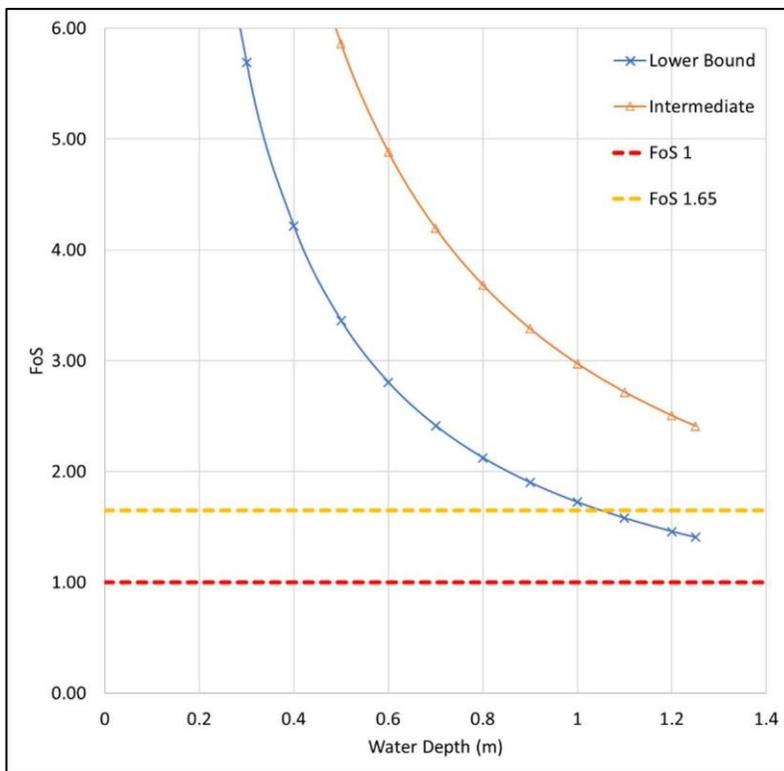
The following graph shows the effect of just increasing the water depth variable against the barrier. For the intermediate case of friction coefficients (repaired road surface), the recommended FoS of 1.65 is achieved at all water depths, however the lower friction coefficients (deteriorated road surface) fall below this recommended FoS at full water height against the barrier.

Figure 30: Representation of how FoS varies with water depth (Source: Arup 2021).

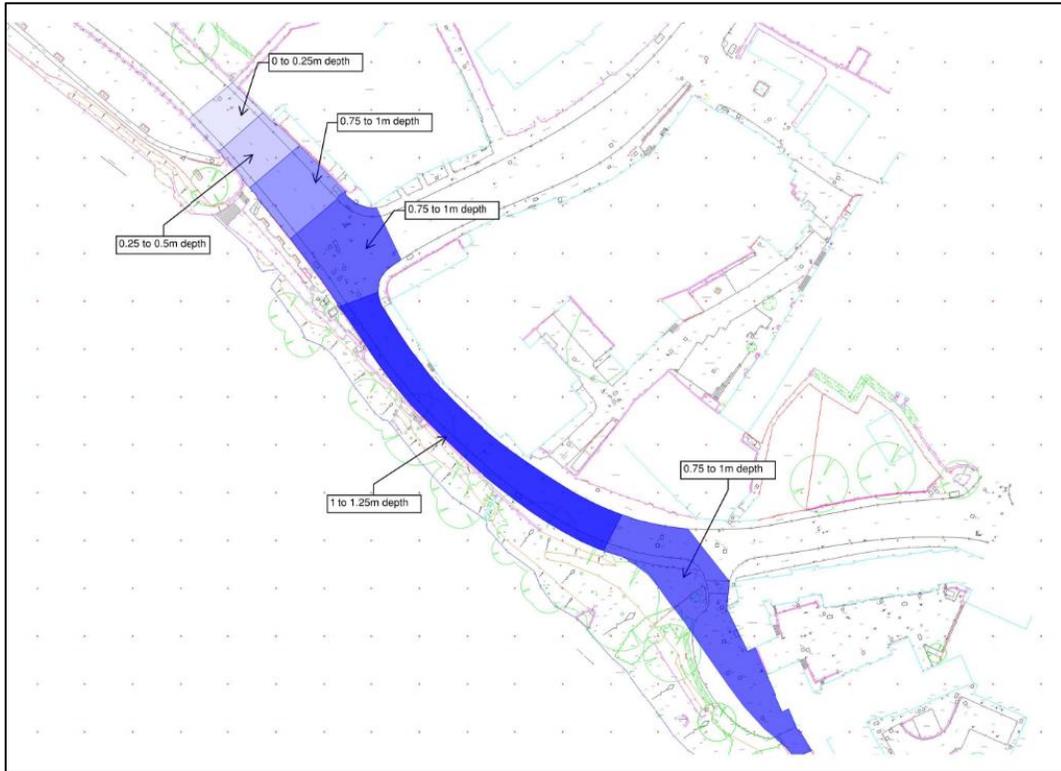
Figure 31 is based on the 2021 topographical survey and demonstrates the water depths in bands across the site at the designed standard of service (5m ASD Bewdley Gauge).

Figure 31: Water depth profile at Beales Corner (Source: Arup 2021).

The lowest section in the centre of the barrier deployment with the largest hydrostatic force against the barrier corresponds to where the barrier failed.

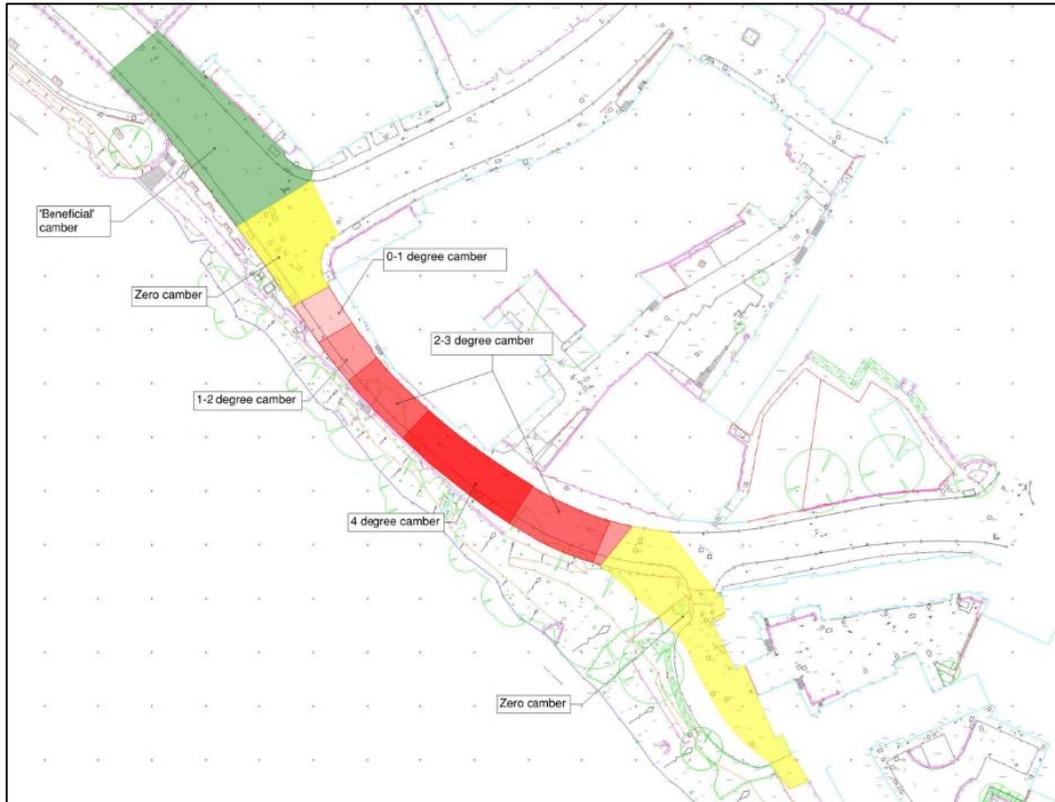
The presence of a camber increases the disturbing forces on the barrier where the camber falls towards the dry side of the barrier. The 2021 topographical survey determined that the camber falls towards the dry side for the majority of the alignment, increasing to a 4 degree negative camber at the location of sliding failure (figure 32).

Figure 32: Camber profile at Beales Corner (Source: Arup 2021).

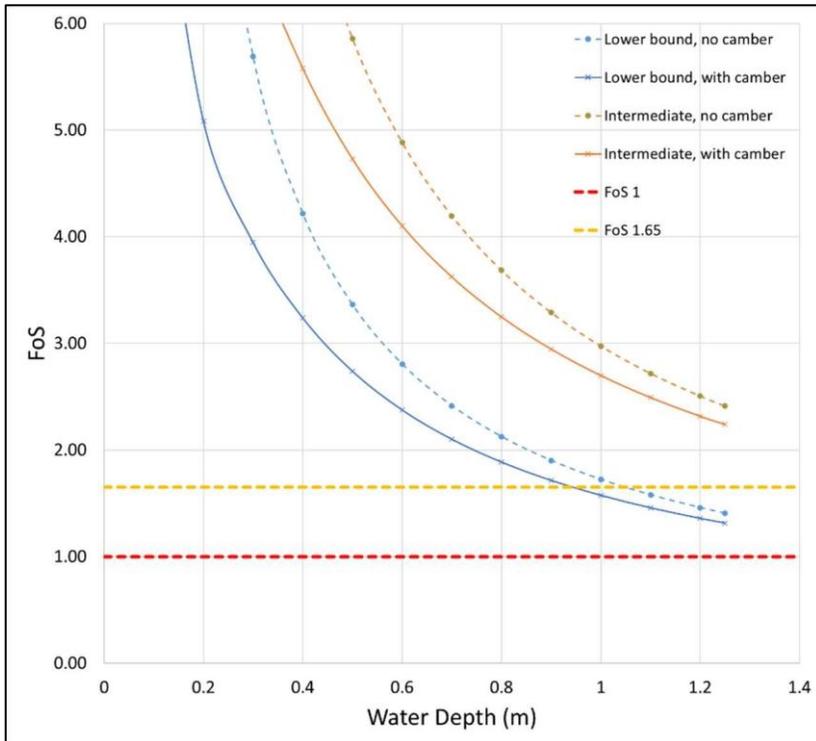
The effect of the camber is shown to be greatest at lower water depths, however this could be one of a number of contributing factors which lowers the overall FoS of the scheme.

Figure 33: Effect of the camber on FoS (Source: Arup 2021).

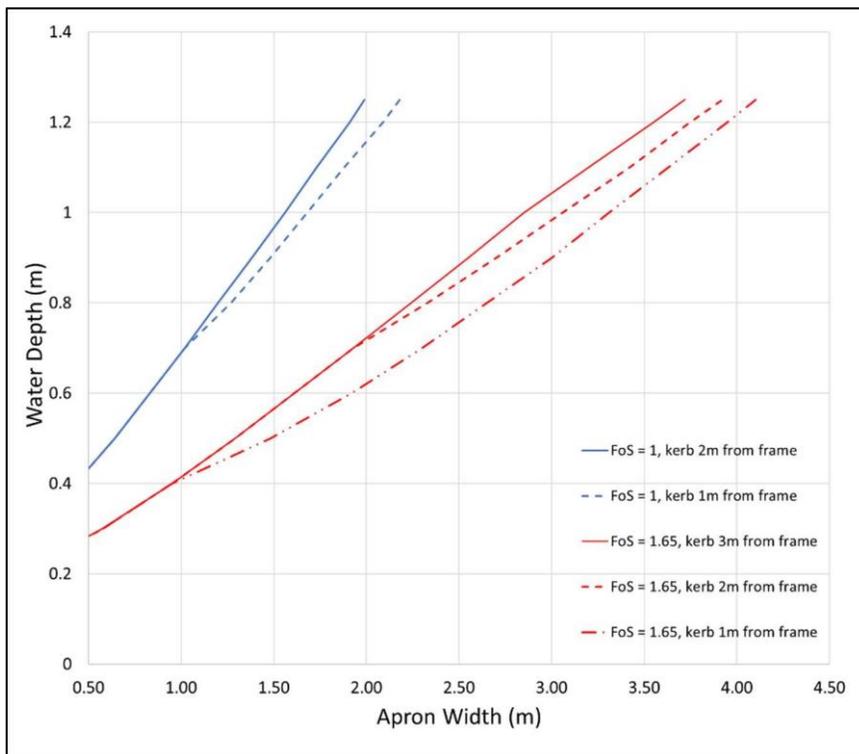
To examine the impact of the varying distances between the kerb and the frame in the current alignment, three cases (where the kerb is 3m, 2m and 1m from the frame), have been analysed for FoS of 1.0 and 1.65. All other variables are kept constant as described in Section 5.3. The assessment using the lower case friction coefficients (deteriorated surface) has shown that to achieve the recommended FoS, a significant 0.4m increase in membrane apron width may be required in the instances where the pavement is located 1m away from the frame, compared when the pavement line is 3m away (Figure 34).

Figure 34: Effect of water depth on membrane length – lower bound (Source: Arup 2021).

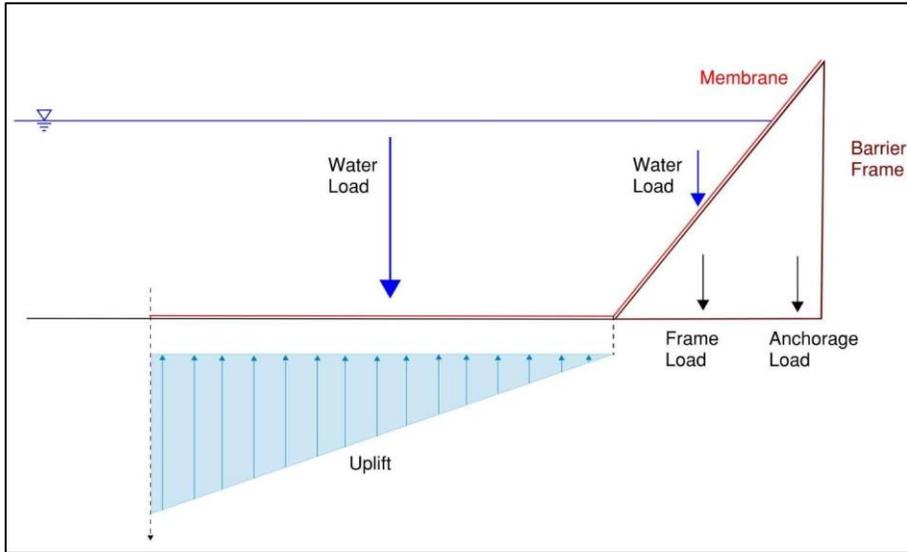
Adopting the principles of hydraulic flow through a soil, a differential in water level and therefore head exists along the membrane length leading to a hydraulic gradient being developed along the 'gap' between the membrane and the asphalt (see figure 36). Applying Darcy's Law, this hydraulic gradient will lead to water flow beneath the membrane and the asphalt.

Figure 36: Mechanism 1, hydraulic gradient between the membrane and the asphalt (Source: Arup 2021).

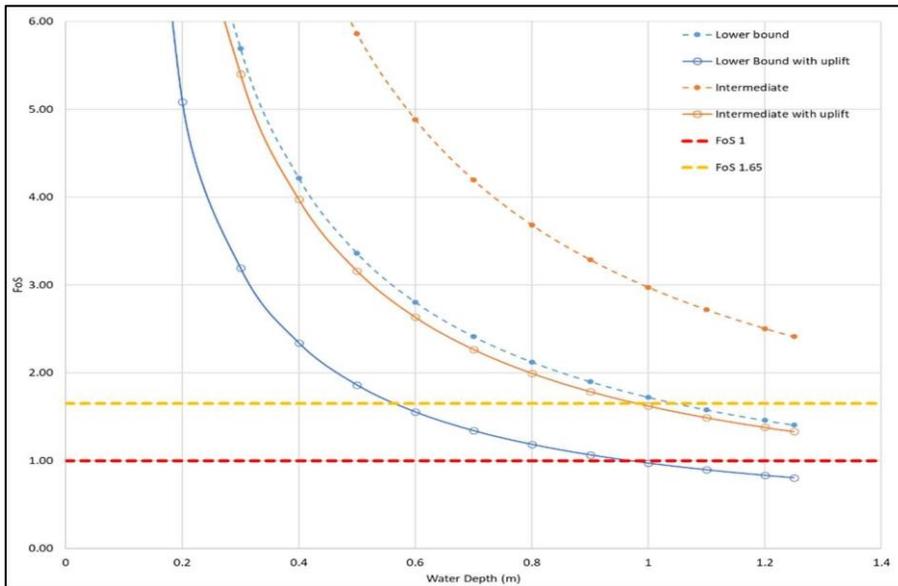
The impact of Mechanism 1 is calculated as significant, for the lower bound case the FoS drops below the recommended value at an approximate water depth of 0.55m and for the intermediate case at a water depth of 1.0m.

Figure 37: Mechanism 1, FoS with water depth (Source: Arup 2021).

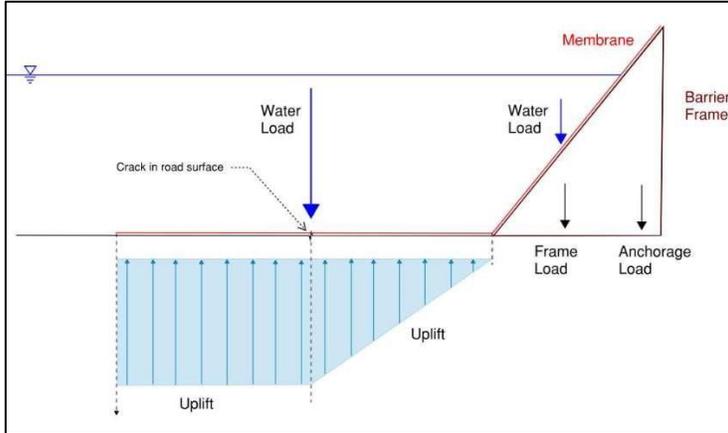
The formation of a crack in the highway surface will increase the uplift pressure beneath the membrane at the point of the crack. The location of the crack in this assessment is critical, as it dictates the distribution of uplift pressure beneath the membrane and therefore the resultant uplift force (see figure 38). For the purpose of this assessment, it has been assumed that the crack is located a) at the frame, b) 1m from the frame, and c) 2m from the frame.

Figure 38: Mechanism 2 - Crack in road surface under membrane (Source: Arup 2021).

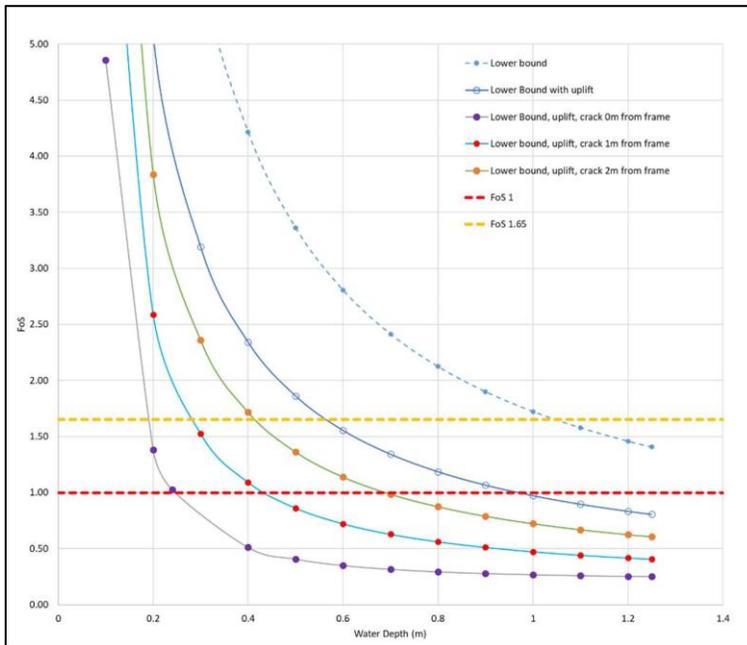
For the lower bound coefficient of friction, the analyses show that the closer the crack location to the frame, the greater the uplift force generated and therefore the lower the FoS (figure 39).

Figure 39: Mechanism 2 - FoS with water depth (Source: Arup 2021).

The worst case occurs when there is a surface crack close to the frame location, as the corresponding water height for the recommended FoS of 1.65 is 0.15m. This effectively negates the frictional force provided by the membrane, and as a result the sliding resistance is only being offered by the frame.

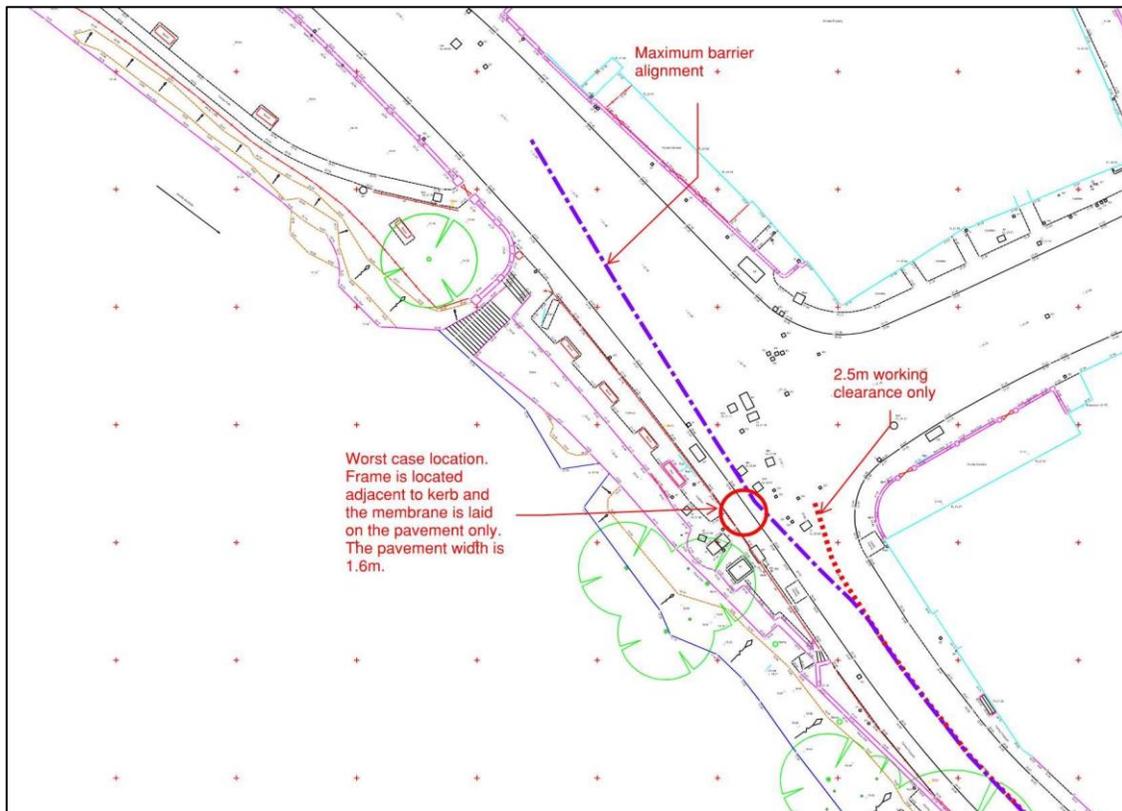
Figure 41: Extract of the maximised route, showing pinch point at junction between Kidderminster and Stourport Roads (Source: Arup 2021).

The pinch-point of the scheme with the narrowest achievable membrane apron width is at the junction between Stourport Road and Kidderminster Road (Figure 41). The membrane apron width is 1.6m located fully on the pavement, avoiding the access chambers utilised by Severn Trent during an incident.

The alignment assumes a 2.5m working space behind the barrier system (the EA Field Operations Team suggest a minimum access width required is 2.2m) to allow for teletruck units to erect and access the defence. An additional 1m of width has been reserved due to the likelihood of an anchoring system becoming necessary.

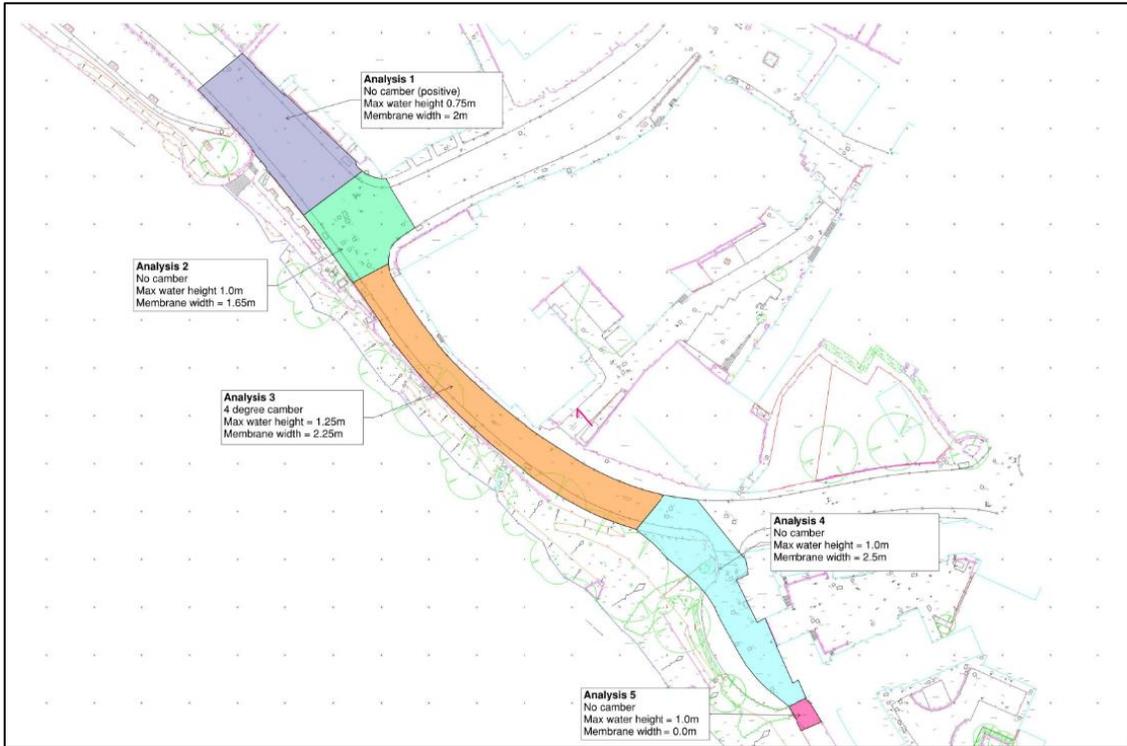
Figure 42: Zoning of the site for FoS Analysis. (Source: Arup 2021).

Due to the large number of factors will the potential to reduce the frictional resistance to sliding, this alignment was further divided into 5 zones for analysis (figure 42), supported by the camber and water depth heat maps (figures 32 and 31).

The variables discussed throughout this section of flood depth, road camber, proximity to the kerb line, membrane apron width, road surface and uplift were combined in the sliding review (Arup 2021) to provide individual assessments of the 5 zones making up the optimised barrier alignment (Figure 42). The camber was accounted for by resolving the frictional forces to determine the horizontal component associated with the applied normal forces. The height of water on the membrane was modified to account for the kerb, and so the normal force mobilised by this has reduced. The uplift force has been established by considering the water head at the wet end of the membrane and assuming this force distribution decreases from a maximum water head at the wet side, to zero water head at the barrier. The assessments assume that the carriageway is in good, resurfaced condition.

Zone 1 has no camber, a maximum water depth of 0.75 and a minimum membrane apron width of 2m. The recommended FoS of 1.65 is achieved without the need for additional restraint

Zone 4 has no camber, a maximum water height of 1m and a maximum membrane width of 2.5m. The recommended FoS of 1.65 is achieved without the need for additional restraint.

Zone 5 has no camber, a maximum water height of 1m and a maximum membrane width of 0m. Additional restraint is required.

Recommendation 19: Where the sliding assessment concludes that the recommended FoS cannot be achieved solely through maximising the alignment of the barrier footprint, additional passive restraint will be required to enable the safe redeployment of that section (zone).

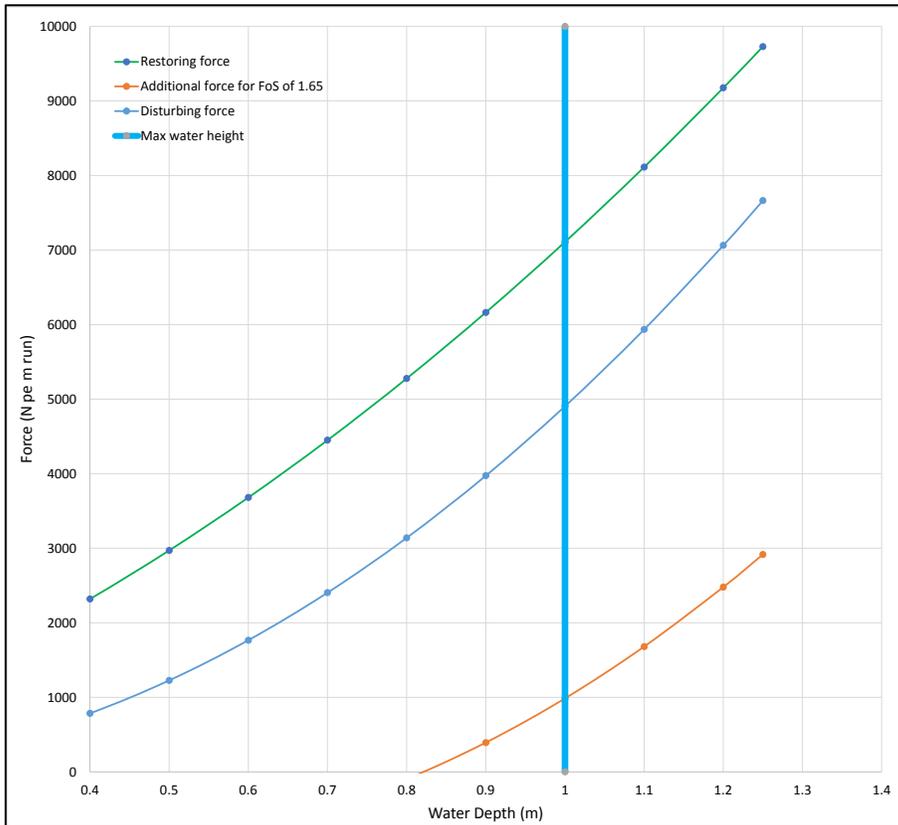
Figure 43: Zone 2: Additional force required at maximum water height (Source: Arup 2021).

Zone 2 has no camber, a maximum water height of 1m and a maximum membrane width of 1.65m, all sited above the kerb on the footpath. The FoS falls below the recommended value at a water height of 0.8m, therefore additional restraint is required. At maximum water height this is calculated at 984 N/m run (figure 43).

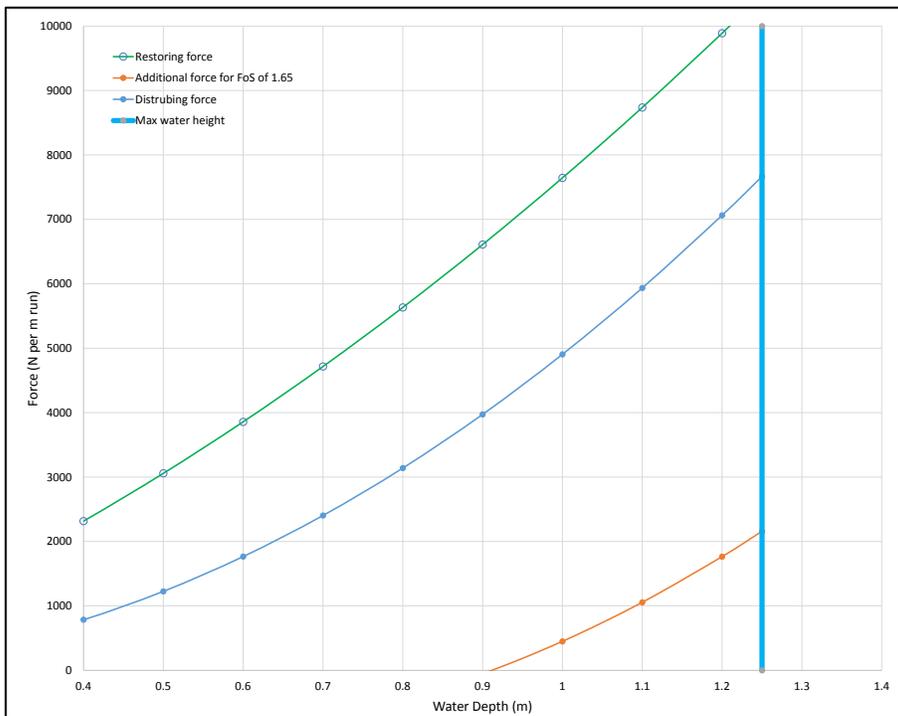
Figure 44: Zone 3: Additional force required at maximum water height (Source: Arup 2021).

Zone 3 has a 4 degree camber, a maximum water height of 1.25m and a maximum membrane width of 2.25m. The FoS falls below the recommended value at a water height of 0.9m, therefore additional restraint is required. At maximum water height this is calculated at 2158 N/m run (figure 44).

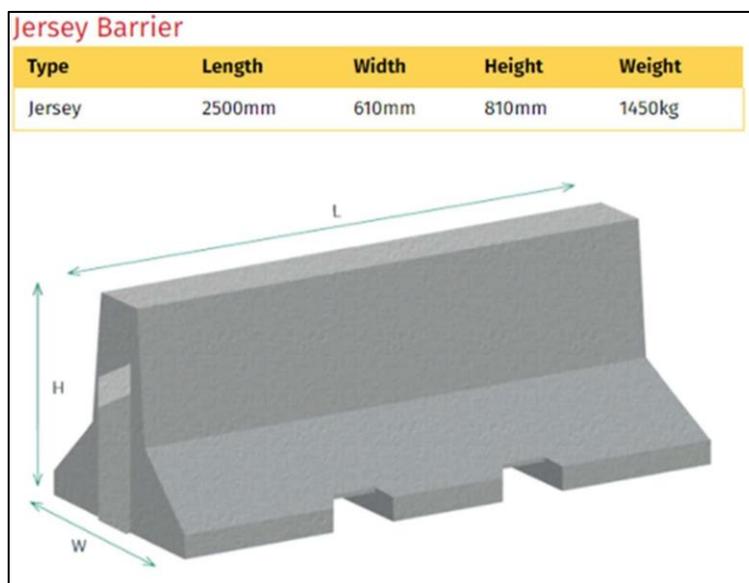
Figure 45: concrete barrier available to provide additional resistance force

Concrete barriers could be utilised to provide extra resistance, they can be deployed on site directly behind the barrier system legs if a steel section or similar is used to ensure that the temporary barrier and the additional restraint act as one system and the resisting force is spread across the multiple legs.

Recommendation 21: Passive restraint measures should be agreed to ensure deployment can be achieved in a safe and timely manner allowing for site constraints.

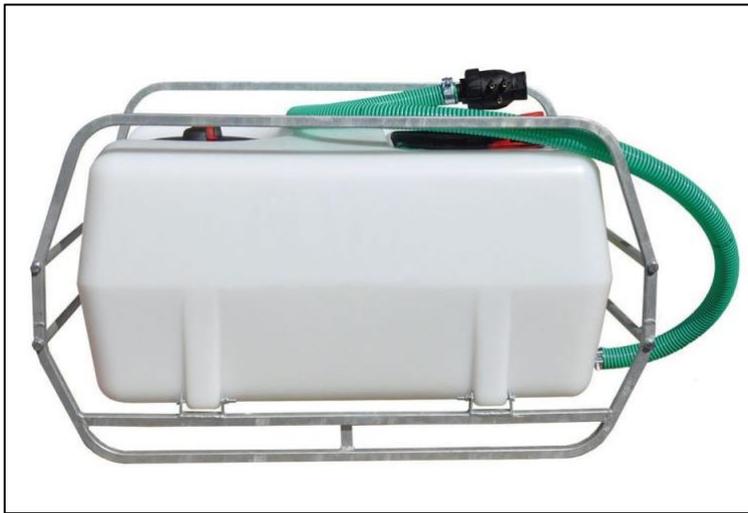
Figure 46: Bowser within a skid frame presented as an option to provide additional resistance force.

Again, steel sections (or similar) behind the feet of the frames, are required to distribute the anchoring forces across individual sections. Bowsers can either be sat directly onto the tarmac surface or be positioned in skid frames (as in Figure 46). The advantage of the skid frames

would be that a higher coefficient of friction could be achieved for this restraint (as steel on asphalt is greater than plastic on asphalt), but this would hinder the ease of deployment of the bowsers and the footprint would be larger.
